Salisbury Quarry Homeowners Association

Salisbury Quarry Pocket Park Pond Report

Storm Water Retention Pond

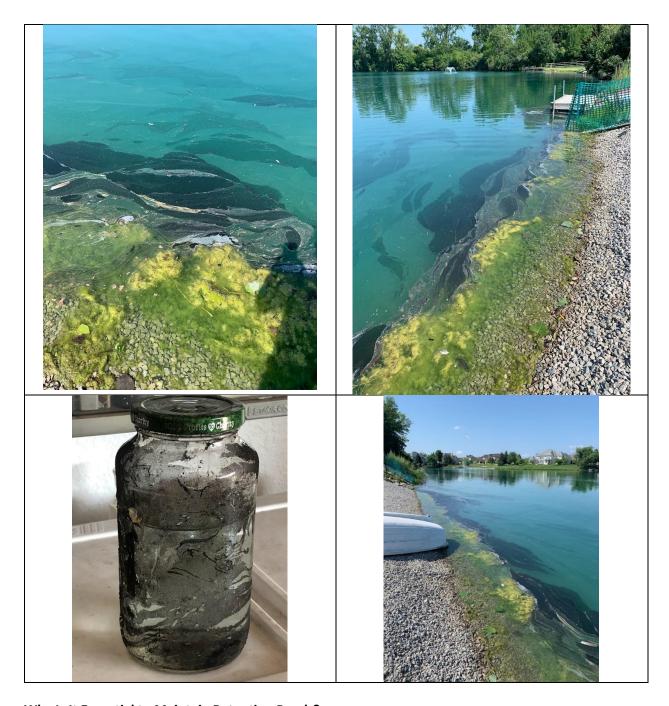
Oil Spill July 4, 2023

In the mid-morning of July 4, 2023 we had what appeared as an oil spill of several hundred gallons of oil come in through the pocked Park Quarry road drain inlet pipe. See the link below for photos and a video. John Walczak personally was on the pond that morning and saw the fluid enter the drain pipe at Pocket Pock. Personally, he theorizes someone who routinely does truck maintenance on Quarry Road emptied an oil collection container through a garage drain but obviously cannot be verified. A caution note was mailed to all residents along with their picnic notice.

- 2. Blake said "Some of the photos you sent me certainly look like Microcystis, a species of cyanobacteria extremely commonly seen during the warm summer months (June-August). This cyanobacterium presents much like a thin film on the surface of the water and can vary in color. I once had a customer send me a photo of their pond that looked like a rainbow caused by Micro. This species poses no concern for human health, and is treated similarly to the filamentous algae we are targeting during our biweekly treatments. As such, I will keep my eyes peeled for it when on site and treat accordingly for it as well."

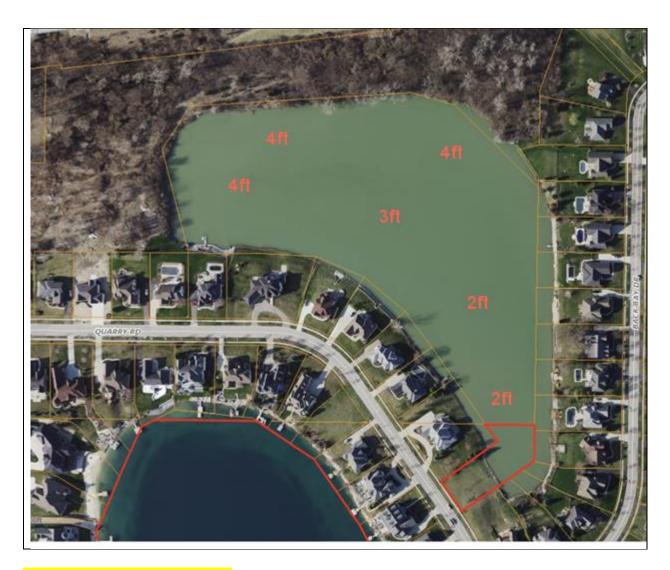
Property North and West of Pocket Pock Pond

Currently the property is experiencing heavy erosion into the pond. The property is not in the Salisbury HOA. Our lawyer advised since the property is not in the HOA but the pond is totally in the HOA the owner is not obligated to contribute to maintenance of the pond.
